Influence of Aging Heat Treatment on Pitting Corrosion Resistance of Martensitic Stainless Steel

Abstract

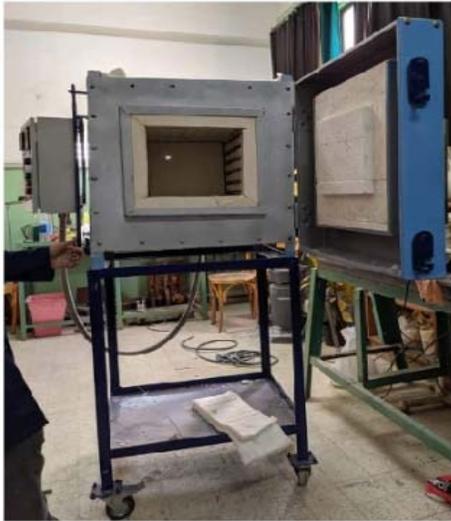
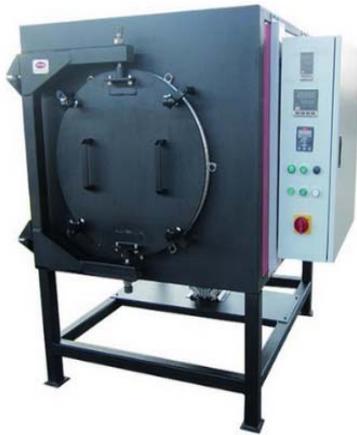
Fig. 1a. Two Electric Furnaces for heat treatment.

The samples were heated using two electric furnaces as shown in Figure (1a), the first for the dissolution treatment and the second for the aging process .

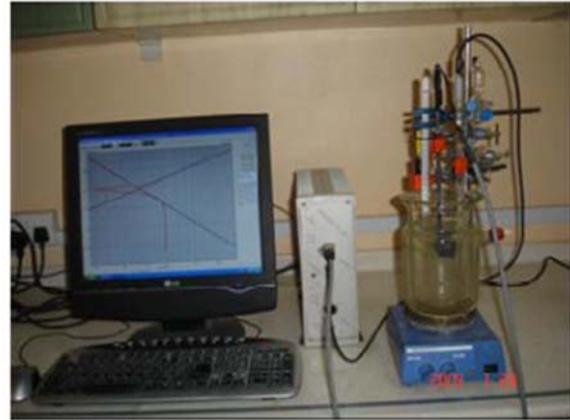
Fig. 1b. The Chemical Corrosion Test.

Chemical corrosion testing or acceleration testing is an effective widely used method in estimating the chemical corrosion in aqueous media by passing a current into the electrode using an inert electrode. The degree of polarization is determined by measuring the sample voltage, while the rate of electrode reaction is measured from the density of the cell current that it directly transmits to a chemical corrosion rate measured in mm/year. The anode and cathode polarization diagrams of electrodes (samples) exposed to a 6% FeCl_3 solution are plotted and the electrode area is 0.5 cm^2 . These diagrams are obtained using PS6 device connected with a computer. The voltage range was found in all tests from -200 to $+1000 \text{ mV}$, and the scan rate was set to 0.5 mV/s . This test was carried out

at room temperature at the Ministry of Science and Technology / Department of Materials as shown in Figure (1b).

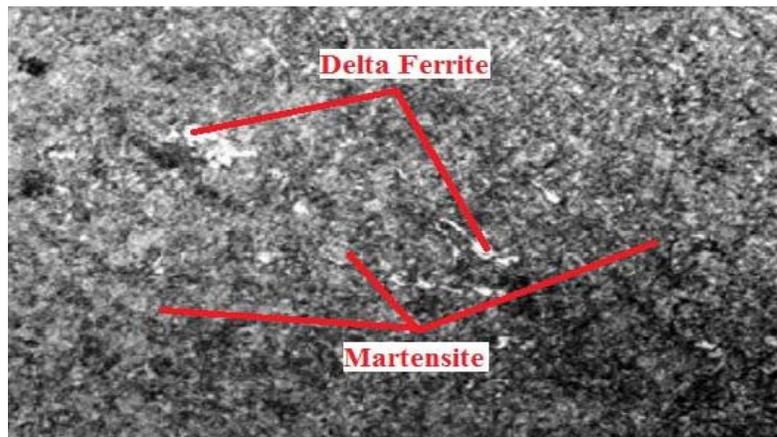
Fig. 2. The microstructure of soluble treated samples at a temperature of 1100 °C (50X).

water. The phases and microscopic components, such as the martensitic matrix and the Delta ferrite phase, were identified using an optical microscope, since the martensitic floor appeared in the form of plates, while the Delta type ferrite appeared in small quantities in the form of longitudinal white ribs, and no presence of austenite was found in this sample, as indicated by in Figure (2).

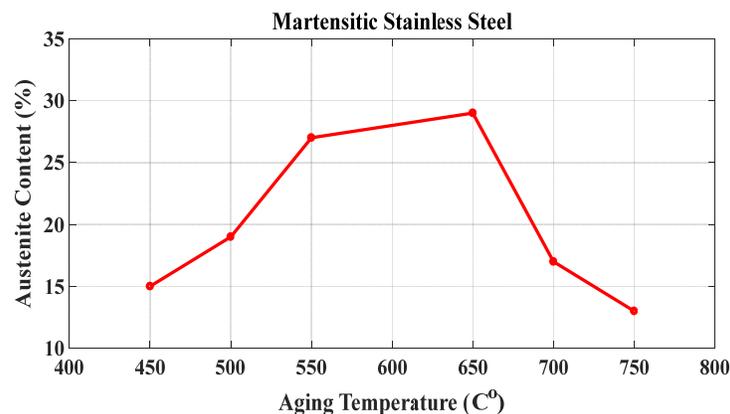
Figure (3) shows the effect of aging temperature on the austenite volumetric percentages. It was found that by increasing the

aging temperature, the austenite volumetric ratios gradually increase, and the maximum value of the austenite volumetric ratios occurs at a temperature of 650 °C. After that, a gradual decrease was occurred down to temperature of 750 °C.

Fig. 3. Effect of four hours aging temperature on volumetric ratio for austenite.

The remaining austenite (quasi-slice austenite) may appear in areas where the returning austenite was formed after hemolytic treatment, so a double needle-shaped microscopic structure consisting of low-carbon martensitic and recovered austenite may be formed in each martensitic slice [8]. It is known that in some types of martensitic stainless steel can be converted to austenite after aging at an aging temperature equal to or above 500 °C [9]. The remaining austenite ratios were found to increase with the aging temperature and time up to 650 °C, as shown in Figures (3 and 4). It was also found that the amount of austenite was increased at the expense of martensitic by increasing the aging time above five hours at a temperature of 650 °C; this means that the amount of martensitic converted to austenite remaining during the heating process at 650 °C increased with the aging time. The volumetric ratio of the austenite after aging process decreases at 700 °C or above compared to the aging process at a temperature range of 500-650 °C as shown in Figure (3); this means that the remaining part of

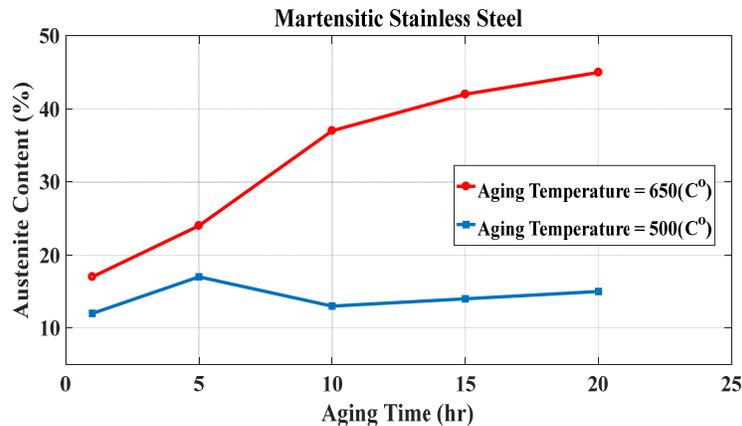
The effect of aging time on the austenite volumetric percentages at 500 and 650 °C aging is shown in figure (4). No significant change in the residual austenite volumetric percentages at

500 °C was noticed. While at aging temperature of 650 °C increases the amount of austenite was significantly increased from 20% to 55%; by increasing the aging time from 1 to 20 hours.

Fig. 4. Effect of aging time on the austenite volumetric percentage at two aging temperatures.

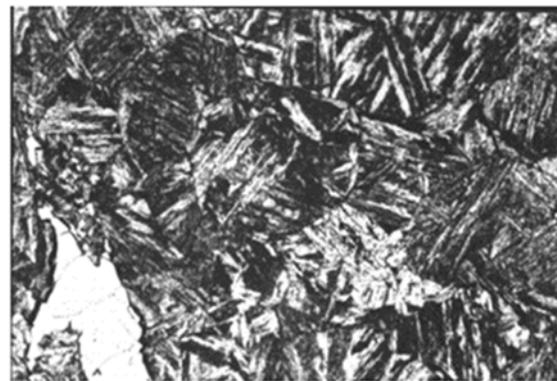
The microstructure of the aging samples at a temperature of 500 °C and a time of 4 hours was shown in Figure (5). The form of elongated carrots, Martensitic slices and also austenitic elongated granules, which arise between the Martensitic slices within the former austenitic granules, leading to the variation of the microscopic structure.

Fig. 5. Microstructure of aging specimens at temperature 500 °C and aging time 5 hrs 200 X.

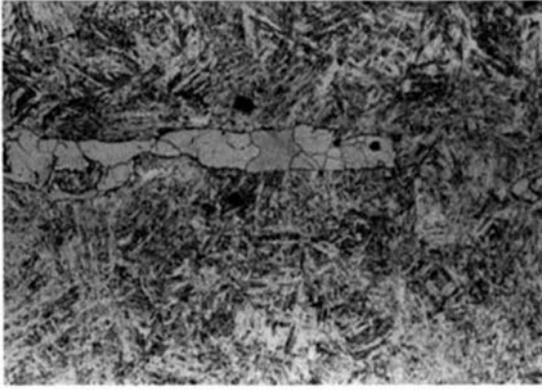
Figure (6) shows the microscopic image of the aging specimens at 500 °C for one hour. The typical low-carbon slice martensitic structure is shown in the former austenitic granule. The transformation of martensitic to austenite becomes more pronounced by increasing the aging temperature and time. At temperature aging of 550 °C for 5 hours the same microstructure as shown in Figure (7) where a high number of

Fig. 6. Microstructure of aging samples at 550 °C for 1 hour (200X).

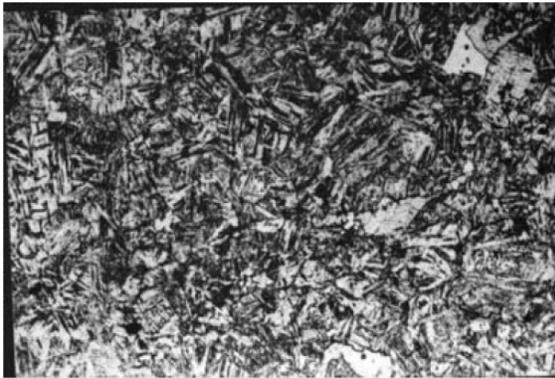
longitudinal grounded austenite were pronounced. This decomposition of martensitic becomes more pronounced at temperatures of (550 and 600 °C) as shown in Figures (7 and 8) below . In this case the austenite volumetric percentage was about 20% as shown from previous Figure (3).

Fig. 7. Microstructure of aging samples at a temperature of 550 °C for 5 hours (100X).

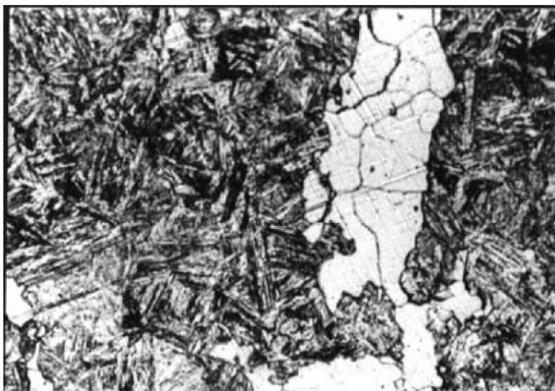
After the aging temperature of 600 °C for 5 hours, the microstructure is almost identical to that of the previous 550 °C as shown in Figure (8), but the residual austenite volume increases to about 30%.

Fig. 8. Microstructure of aging samples at a temperature of 600 °C for 5 hours (200X).

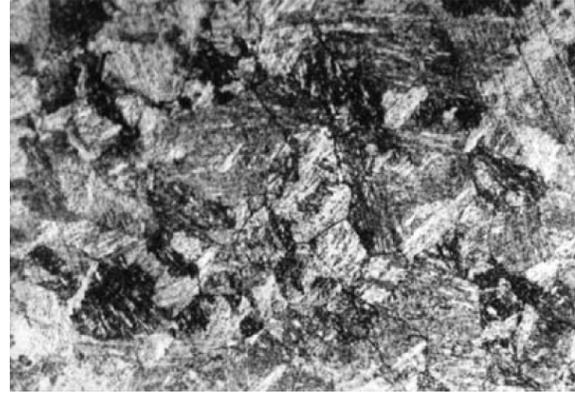
The maximum residual austenite value of 32% is shown in the sample treated at 650 °C for 5 hours as shown in Figure (9). The microstructure seems to be as equal axes granules, which can be seen inside these soft needle-shaped microstructures. Examination of this structure at

Fig. 9. Microstructure of aging samples at 650 °C for 5 hours (200X).

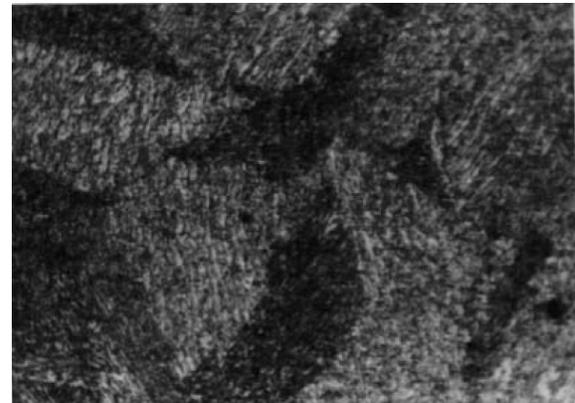
High magnification showed that the residual austenite granules are elongated, and their volumetric ratio increased with the aging time from 1 to 20 hours as shown in Figure (10). The former austenitic granules are dark in color and others are light in color and larger in size.

Fig. 10. Microstructure of aging samples at 650 °C for 16 hours (1000X).

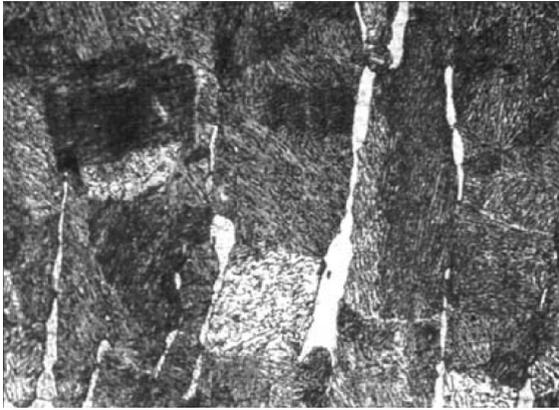
The microstructure of the aging samples at a temperature of 700 °C for 5 hours is shown in Figure (11). In this figure the ribs of ferrite delta type are shown and adjacent to them are often bright white elongated granules and others with almost equal axes. These granules are for the residual austenite which has been converted to non-aging martensitic.

Fig. 11. Microstructure of aging samples at 700 °C for 4 hours (500X)

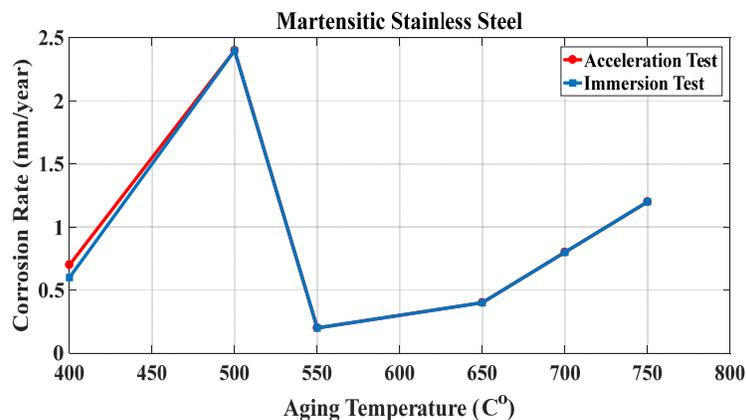
Figure (12) shows the effect of 5-hours aging temperatures on the chemical corrosion rate (with 6% iron chloride acceleration test) and immersion test, as it appears from this form the following points:

1. The chemical corrosion rate is increasing sharply in the aging temperature range from (500 to 550) °C.
- 2 - The largest value of the rate of chemical corrosion is about 2.5 mm / year; when aging to a temperature of 550 °C.
3. The chemical corrosion rate decreases steeply when aging in a temperature range of (550 to 600) °C
- 4 - The minimum value of the rate of chemical corrosion about 0.2 mm / year that produced at aging range of (550 to 650) °C.
5. The rate of chemical corrosion increases again, gradually, when aging after the previous field.

Fig. 12. Effect of 5-hour aging temperature on chemical corrosion rate due to acceleration test (dynamic voltage test) and immersion test.

Aging-treated samples at 500 ° C have maximum chemical corrosion rate values as shown in Figure (12). This could be due to the presence of delta-type ferrite in the form of longitudinal ribs and the deposition of very small precipitates found to be molybdenum carbides (Mo₂C) [11].

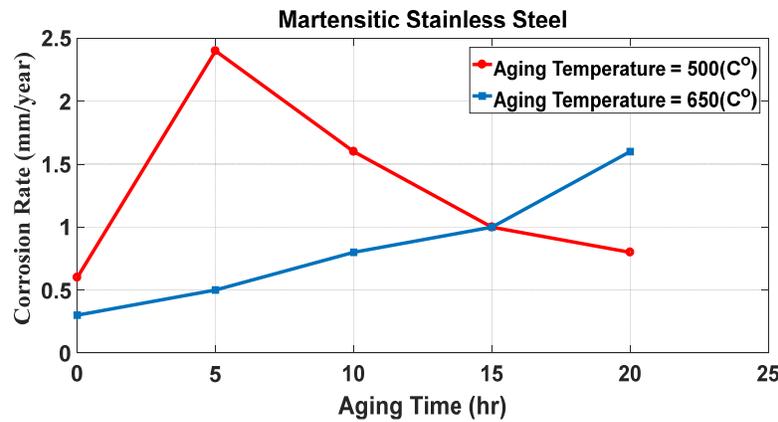
Figure (13) shows the effect of aging time on the chemical corrosion rate; at 550 and 650 °C aging temperatures, when aging at a temperature equal to 550 °C, the initial phase of chemical corrosion increases from 1 to 5 hours. The maximum value of the chemical corrosion rate

was at an aging time of 5 hours, after which the rate of chemical corrosion gradually decreases. When aging at a temperature equal to 650 °C, the chemical corrosion rate gradually increases with the aging time and the increase rate is much faster after aging time of 10 hours.

Fig. 13. Effect of aging time on the chemical corrosion rate of aging samples at an aging temperature of (500 and 650) °C from the accelerometer test (dynamic voltage test).

After aging for 15 hours at 500 ° C, these carbides may begin to disintegrate and this leads to a decrease in the rate of chemical corrosion as shown in Figures. (13 and 16). Aging samples at 550 ° C have the lowest corrosion rate values as shown in Figure (12), and this can be due to the high volumetric ratio of the austenite [12]. The resulting high rate of chemical corrosion after aging for 20 hours at 650 ° C can be attributed to the beginning or growth of Cr₂₃C₆ chromium carbide. After aging at temperatures above 650 ° C, carbides of Cr₂₃C₆ type can become dominant, dominant and heterogeneous deposits in the martensitic floor that leads to an increase in the rate of chemical corrosion.

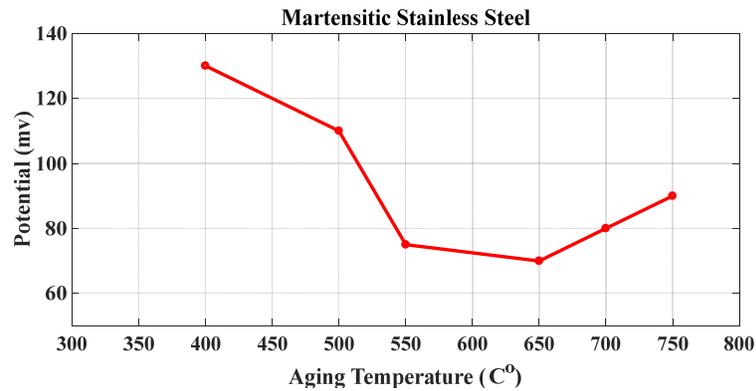
Figure (14) shows the effect of increasing the aging temperature on the voltage; at an aging time of 5 hours, this figure shows the following:

- The voltage decreases gradually by increasing the aging temperature in the range from (500 to

650) °C, and produces the lowest voltage when aging at 650 °C.

- The voltage increases significantly by increasing the temperature in the field from (650 to 750) °C.

Fig. 14. Effect of aging temperature for 5 hours on voltage.

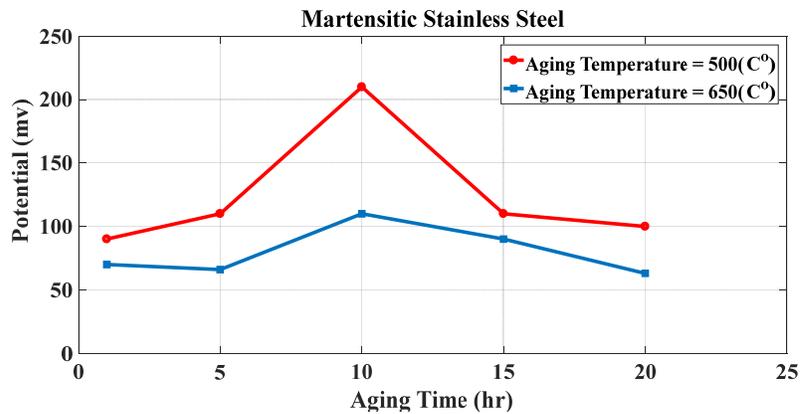
The effect of aging time on voltage is shown in Figure (15) at (500 and 650) °C. An increase in voltage is observed at each aging temperature, starting from an equal aging time to one hour, and the rate of increase is much faster at an aging temperature of 500 °C, and the maximum value of the voltage is produced by aging for 10 hours; this

is at all the two temperature ranges of aging. On the other hand, the voltage decreases gradually when the aging time increases above 10 hours and after (15) hours the rate of decrease is slower. The aging sample at a temperature of 500 °C had a higher voltage than the aging sample at a temperature of

Fig. 15. Effect of aging time on voltage at two aging temperatures.

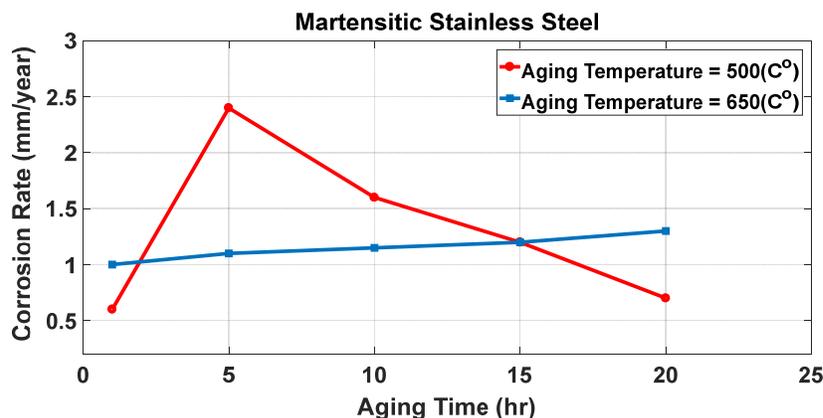
The changes in the chemical corrosion rate resulting from this test are shown in Figure (16). By changing the corrosion time of samples at the aging temperatures of (500 and 650) ° C, the changes in the rate of chemical corrosion by changing the aging time are similar to those resulting from the previous test (the accelerated test), but the values of the chemical corrosion rate are higher in this case.

1. The chemical corrosion rate of aging samples increases at 500 °C, in the first stage of the scheme from the time of aging 1 to 5 hours and the maximum value of the chemical corrosion rate occurs when aging for 5 hours, after which time the chemical corrosion rate gradually decreases with increased aging time.
2. The rate of chemical corrosion gradually increases with the aging time of the aging samples at 650 °C, and the rate of increase is faster after aging time of 15 hours.

Fig. 16. Effect of aging time on chemical corrosion rate of aging samples at 500 and 650 °C aging temperatures.

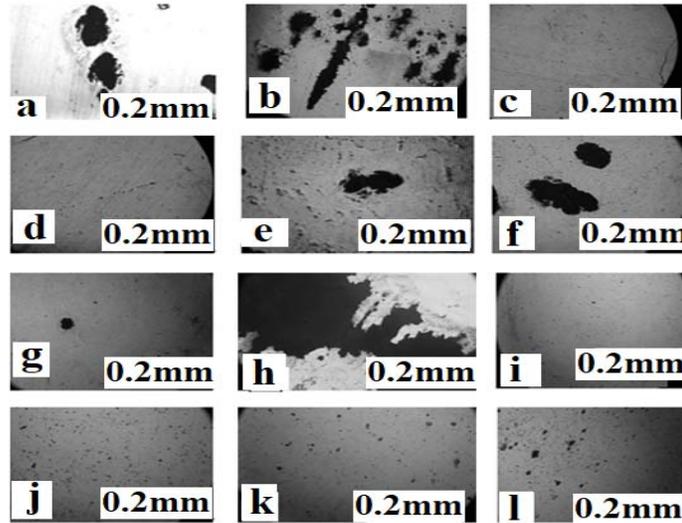
Figures (17) to (19) show microscopic images of aging samples at different aging temperatures and times tested by accelerated testing. From these images it can be seen that there is a deep and large mortise on the surface of the aging sample at a temperature of 550 ° C as shown in

Figure (17b), which corresponds to the high chemical corrosion rate previously measured.

When the sample is released at a temperature of 600 °C, the clicking is smaller and deeper than the rest of the sample as shown in Figure (17c), while the size of the tap formed on the surface of the aging sample at 750 °C is larger than that formed on the sample surface. The aging is 550

°C, but remains smaller than the aging sample at 500 °C, as shown in Figure (17f).

Fig. 17. Microscopic images of aging samples for 4 hours at different aging temperatures. (a, g) 500, (b, h) 550, (c, i) 600, (d, j) 650, (e, k) 700, (f, l) 750 °C, where (a, b, c, d, e, f, acceleration test) and (g, h, i, j, k, l, immersion test).

to chemical corrosion [12]. The large flick size of aging samples at 500 ° C as shown in Figures (17b), (18) and (19b) indicates that these samples are more susceptible to fovea corrosion, which may be due to the formation of molybdenum carbides and the presence of delta type ferrite. It can be concluded that aging samples at 500 ° C for 5 hours are less predisposition than other samples, due to the small click size as indicated by doubt (17c,i) and can be due to high volumetric percentages it remains the result of the dissolution and disintegration of martensitic. The formation of chromium carbides of type Cr₂₃C₆ in aging samples at 750 ° C has led to a second increase in the volume of clicking formed on the surface of aging samples at this temperature.

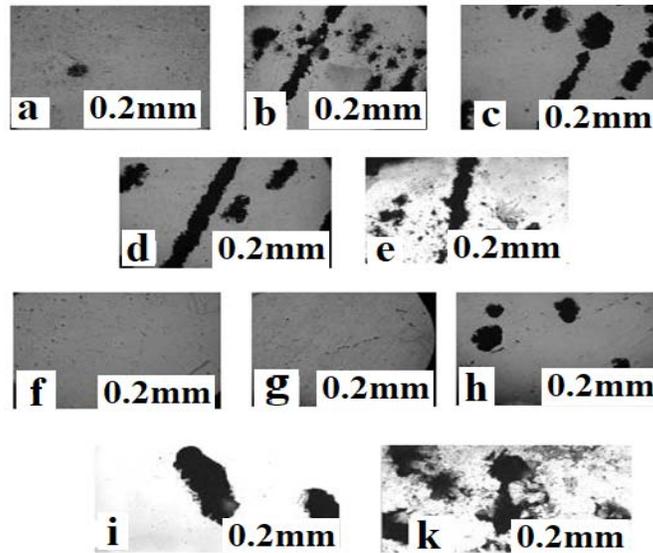
An increase in the aging time with the aging temperature constant at 500 °C indicates that there is a clear decrease in the flick size after being tested by acceleration method as shown in Figure (18), and the smallest flick size after aging is

formed within a period of 20 hours as evident from Figure (18e). Conversely, by increasing the aging time at 650 °C there is a noticeable increase in the size of the flick as shown in Figure (18), and the larger flick size is formed in the sample that was released at 20 hours as shown in Figure (18k).

Fig. 18. Microscopic images of aging samples during different aging times;(a) 1hr, (b) 5hr, (c) 10hr, (d) 15hr, (e) 20hr: acceleration test where (a, b, c, d, e) at 500 °C and (f, g, h, i, k) at 650 °C.

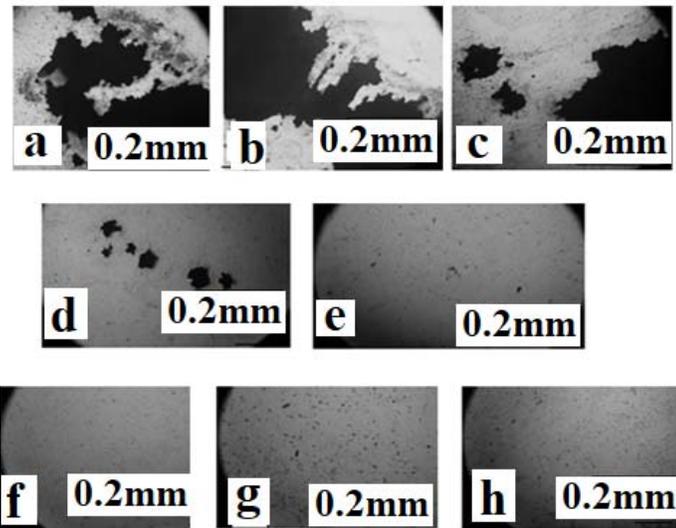
Figure (19) shows the microscopic images of the aging samples at different temperatures and aging times. This is after being tested by immersion method, noting that there is almost no difference in the form of clicking and its size

after aging at different temperatures and aging times; this is when compared to the pictures of the samples tested with the previously explained acceleration test as shown in Figure (18).

Fig. 19. Microscopic images of aging samples during different aging times ;(a) 1hr, (b) 5hr, (c) 10hr, (d) 15hr, (e) 20hr: immersion test where (a, b, c, d, e) at 500 °C and (f, g, h, i, k) at 650 °C.
